**NASA
Technical
Memorandum**

NASA TM -86529

**COMPUTED TOMOGRAPHY FOR NON-DESTRUCTIVE
EVALUATION OF COMPOSITES: APPLICATIONS
AND CORRELATIONS**

August 1985

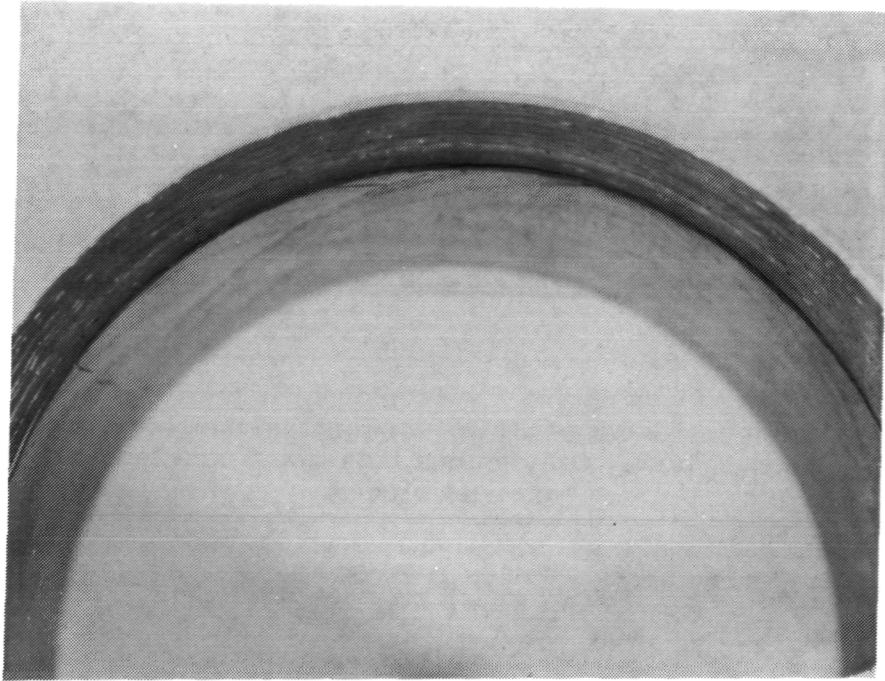
Figure 6. Delamination in GEBS. (Delamination visible through cylinder ID.)

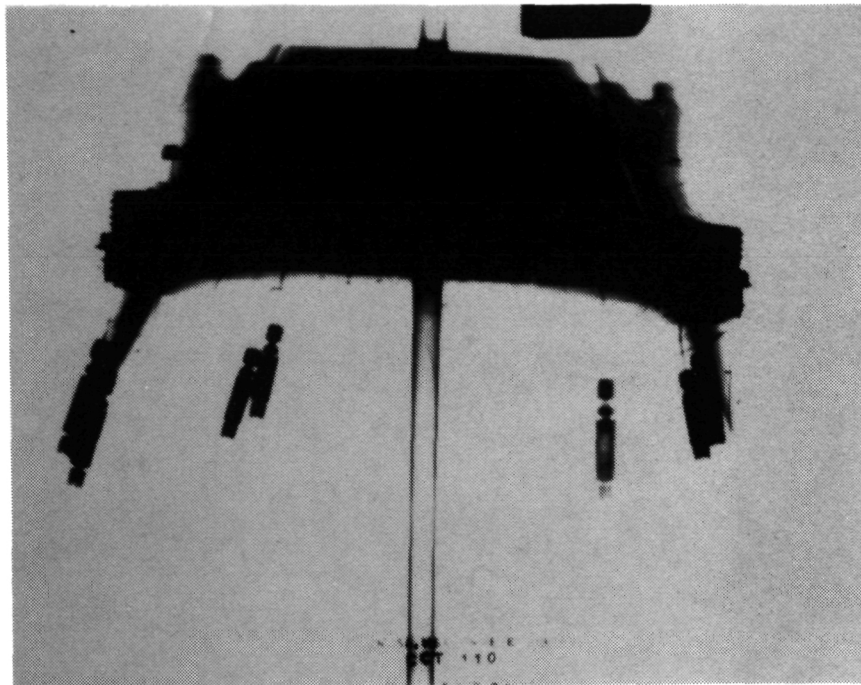
Figure 10. Tangential RT of CCT-1/MSFC. (Post-test RT of CCT-1 supported by CT alignment fixture. Note circumferentially non-uniform gap. View is 110 deg true tangential.)

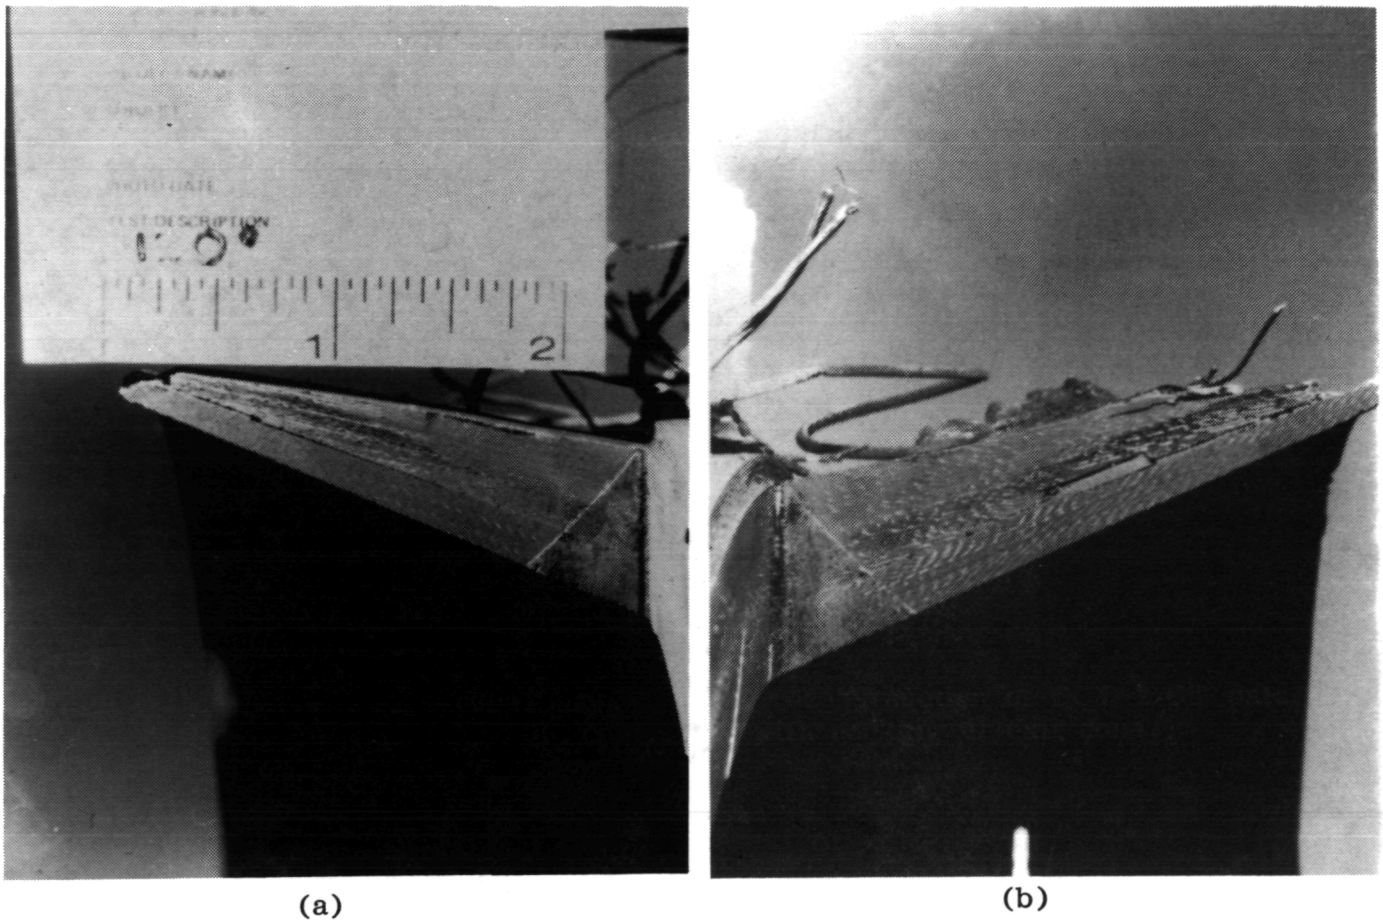
Figure 17. Cross-section of CCT-1/aft segment. (Visual observations reveal instrumentation sites, delamination region (b), and char indications.)

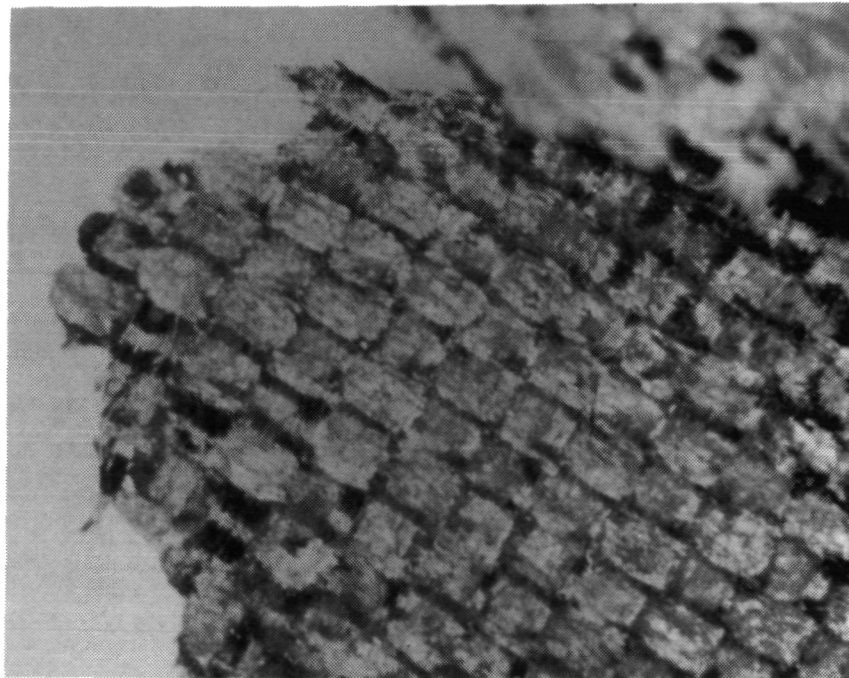
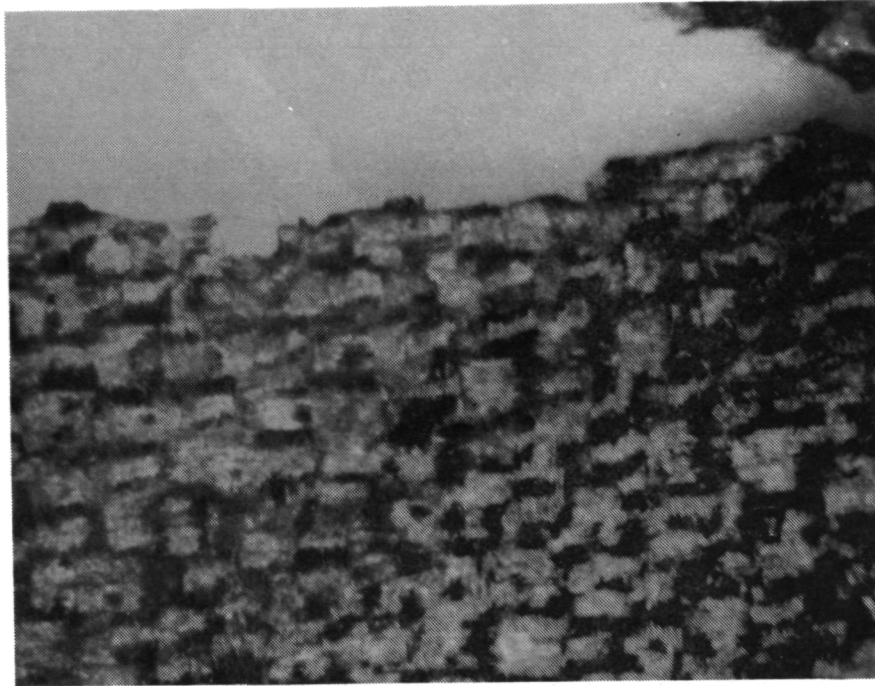
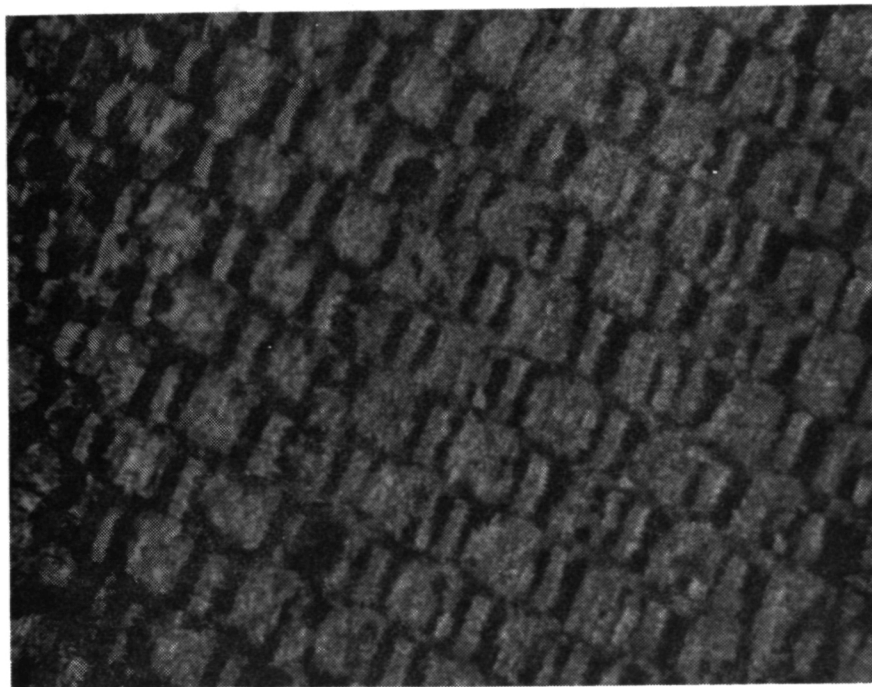
Figure 22. 220 deg region micrographs. (a) Crack juncture outside of matrix-full region; fiber bundle surfaces not evident. (b) Crack juncture inside; rougher surface appearance, some fiber bundle surface visible. (c) Dry ply region below stiffener ring cracks surface; high incidence of visible matrix-poor clean fiber bundles.)

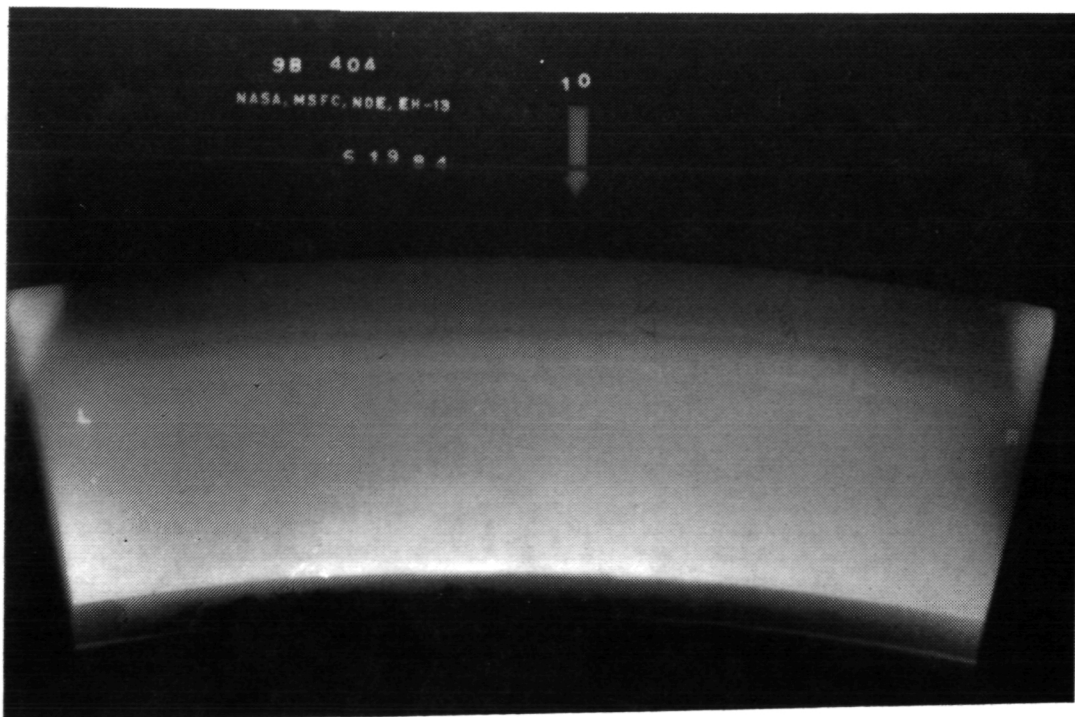
Figure 28. RT of unfired SRM samples/radial. (a) Note internal density variations, cloth patterns, and cloth-to-cloth lacing patterns.
(b) Note delaminations, resin-starved regions, and cloth patterns.

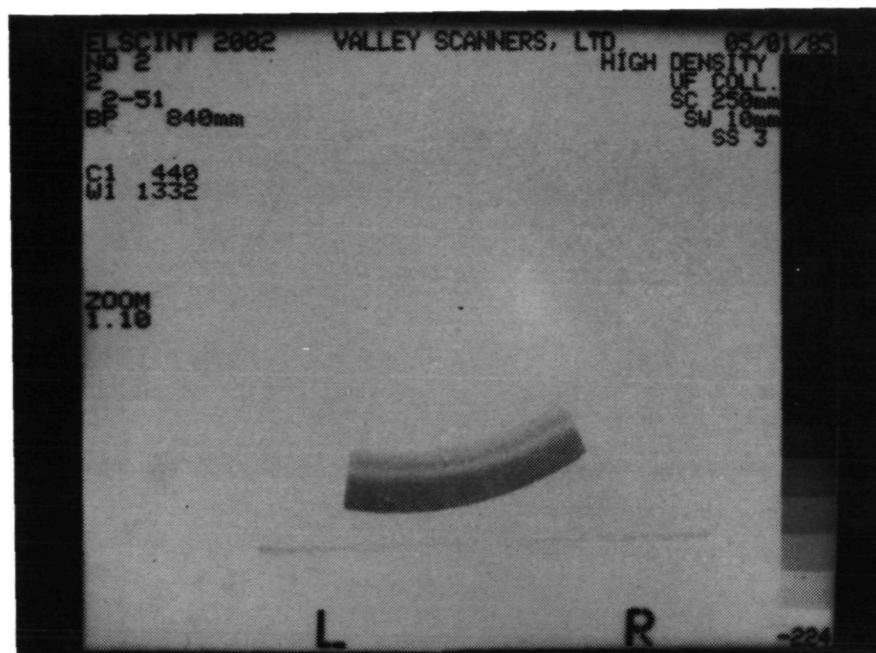
Figure 32. CT of NQ2/forward section. (a) Char/heat-affected regions are delineated by minimum density regions. (b) Identical to (a). Note clarity of char profile.
